FLARM FIRMWARE RELEASE NOTES	Date: 2022-06-06 Version: 1.1 Page: 1 of 42
FLARM Technology AG Industriestrasse 49 CH-6300 Zug		Document Number: FTD-037

FLARM Firmware Release Notes

Published 19 December 2024

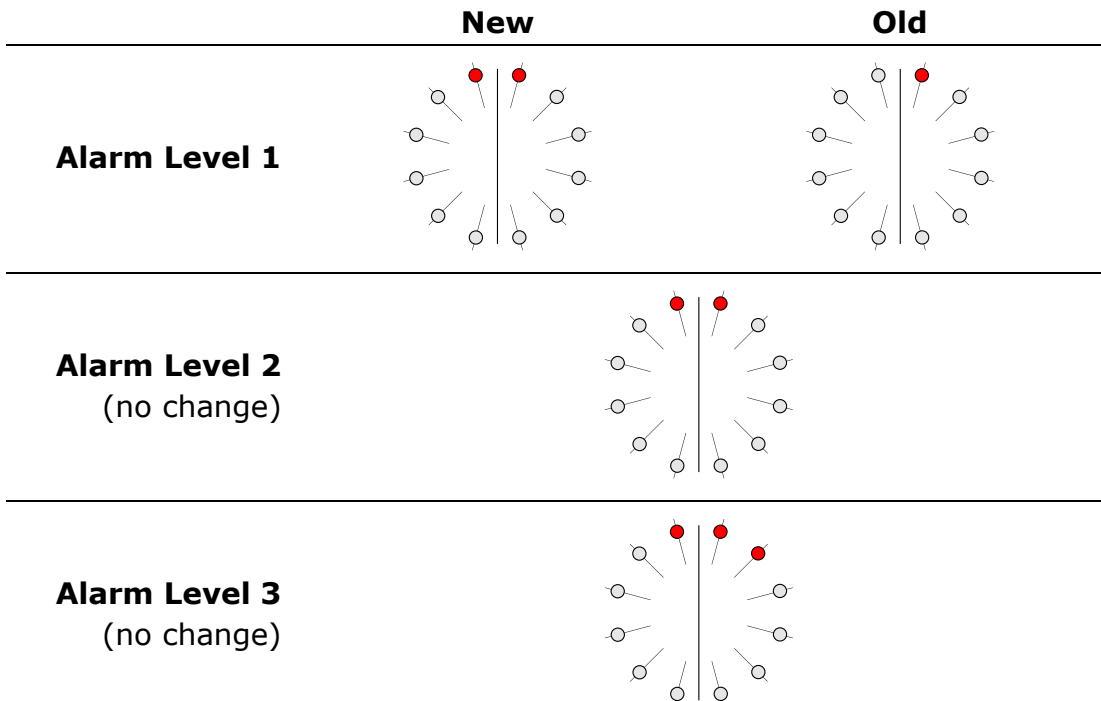
Note: Head-on ($\pm 15^\circ$) traffic and collision warnings on Classic FLARM F6–F9 are indicated as shown in the graphic below (the traffic in this example comes from $+5^\circ$ relative bearing).
