| | <h1>FLARM FIRMWARE RELEASE NOTES</h1> | Date: 2022-06-06 Version: 1.1 Page: 1 of 41 |

FLARM Firmware Release Notes

Version 7.25

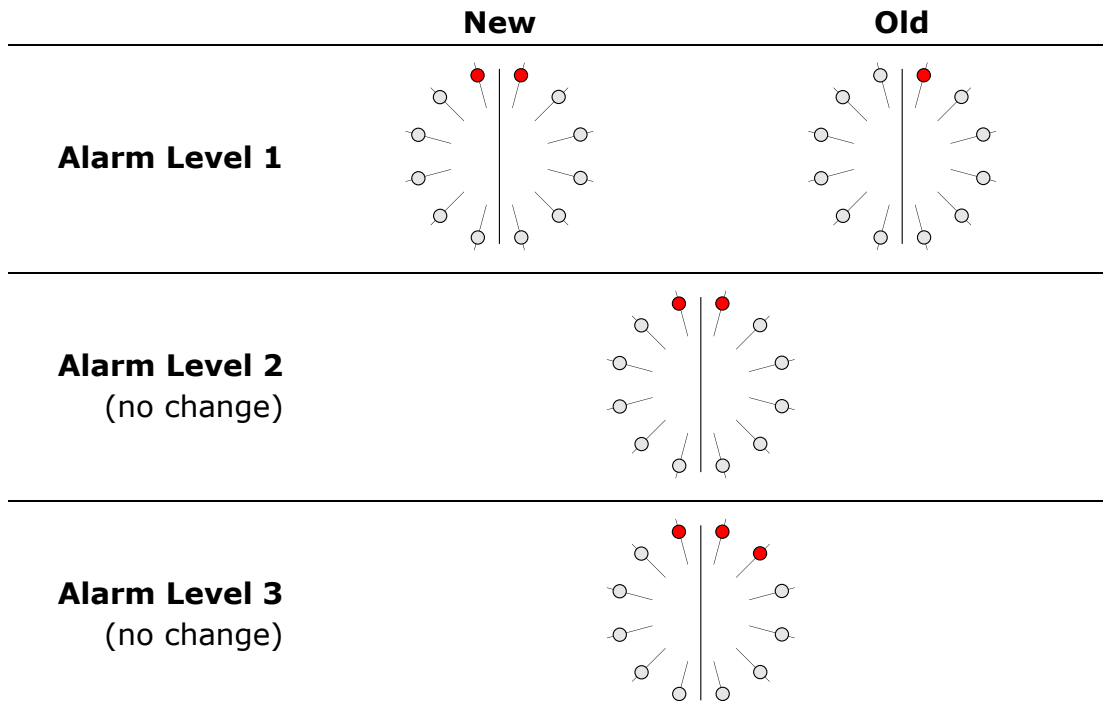
Note: Head-on ($\pm 15^\circ$) traffic and collision warnings on Classic FLARM F6–F9 are indicated as shown in the graphic below (the traffic in this example comes from $+5^\circ$ relative bearing).
