<h1>FLARM FIRMWARE RELEASE NOTES</h1>	Date: 2022-06-06 Version: 1.1 Page: 1 of 38
FLARM Technology AG Industriestrasse 49 CH-6300 Zug		Document Number: <b>FTD-037</b>

# FLARM Firmware Release Notes

## Version 7.22

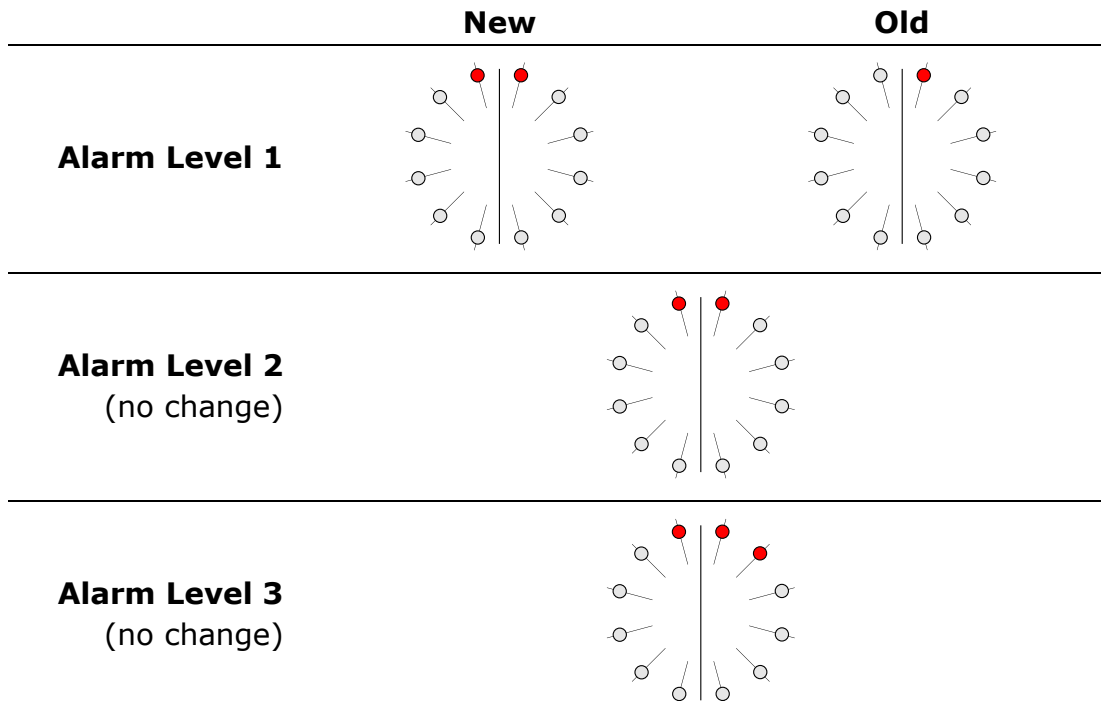
**Note:** Head-on ( $\pm 15^\circ$ ) traffic and collision warnings on Classic FLARM F6-F9 are indicated as shown in the graphic below (the traffic in this example comes from  $+5^\circ$  relative bearing).
